Intel[®] Pentium[®] III Xeon[™] Processor Specification Update

Release Date: June 2000

Order Number: 244460-016

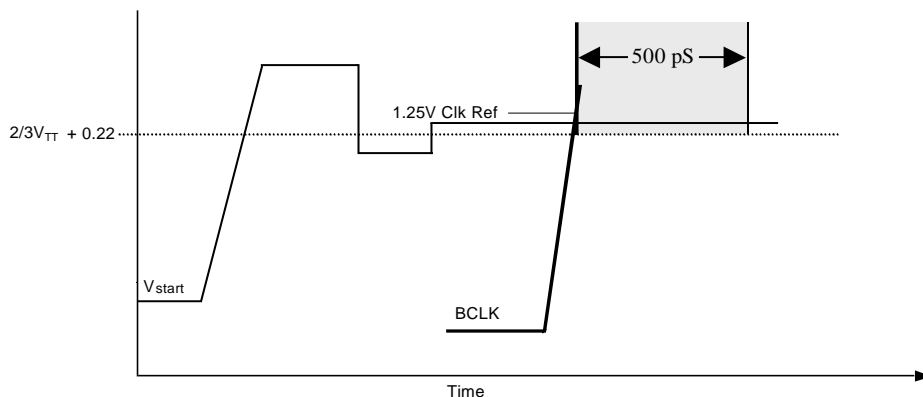
The published AGTL+ AC specification for $V_{IH(MIN)}$ is $(2/3 \cdot V_{TT}) + 0.1$ Volts.

Intel has characterized the new AGTL+ AC specification for $V_{IH(MIN)}$ on the processor's RS0# signal to be: $(2/3 \cdot V_{TT}) + 0.22$ Volts within 500 picoseconds following the rising edge of BCLK crossing the 1.25-Volt threshold. See below.

Implication: The deviation from the published specification results in decreased noise margin on the RS0# processor input. This decreased noise margin has been observed to be particularly detrimental in system environments where the RS0# processor input is being driven by an I/O buffer with a pull-up device (such as a p-channel transistor) that is switched off mid-cycle. Systems that employ I/O buffers that keep the pull-up device on for the entire cycle are significantly less affected by this erratum. The reduction in noise margin may lead to the generation of BINIT# (when enabled) resulting in a system reset, otherwise this condition may lead to a system "hang" condition.

Workaround: If a system design cannot meet the specification deviation, the following areas should be carefully examined to assure that additional margin exists in order to compensate for any deficit observed with respect to the newly characterized $V_{IH(MIN)}$ specification:
